DEPARTMENT OF DEFENCE
DEFENCE SCIENCE AND TECHNOLOGY ORGANISATION
MATERIALS RESEARCH LABORATORIES
MELBOURNE, VICTORIA

MRL-R-1060

AN EXAMINATION OF COATING FAILURE ON WING PIVOT FITTINGS
OF F111 AIRCRAFT

L.V. Wake

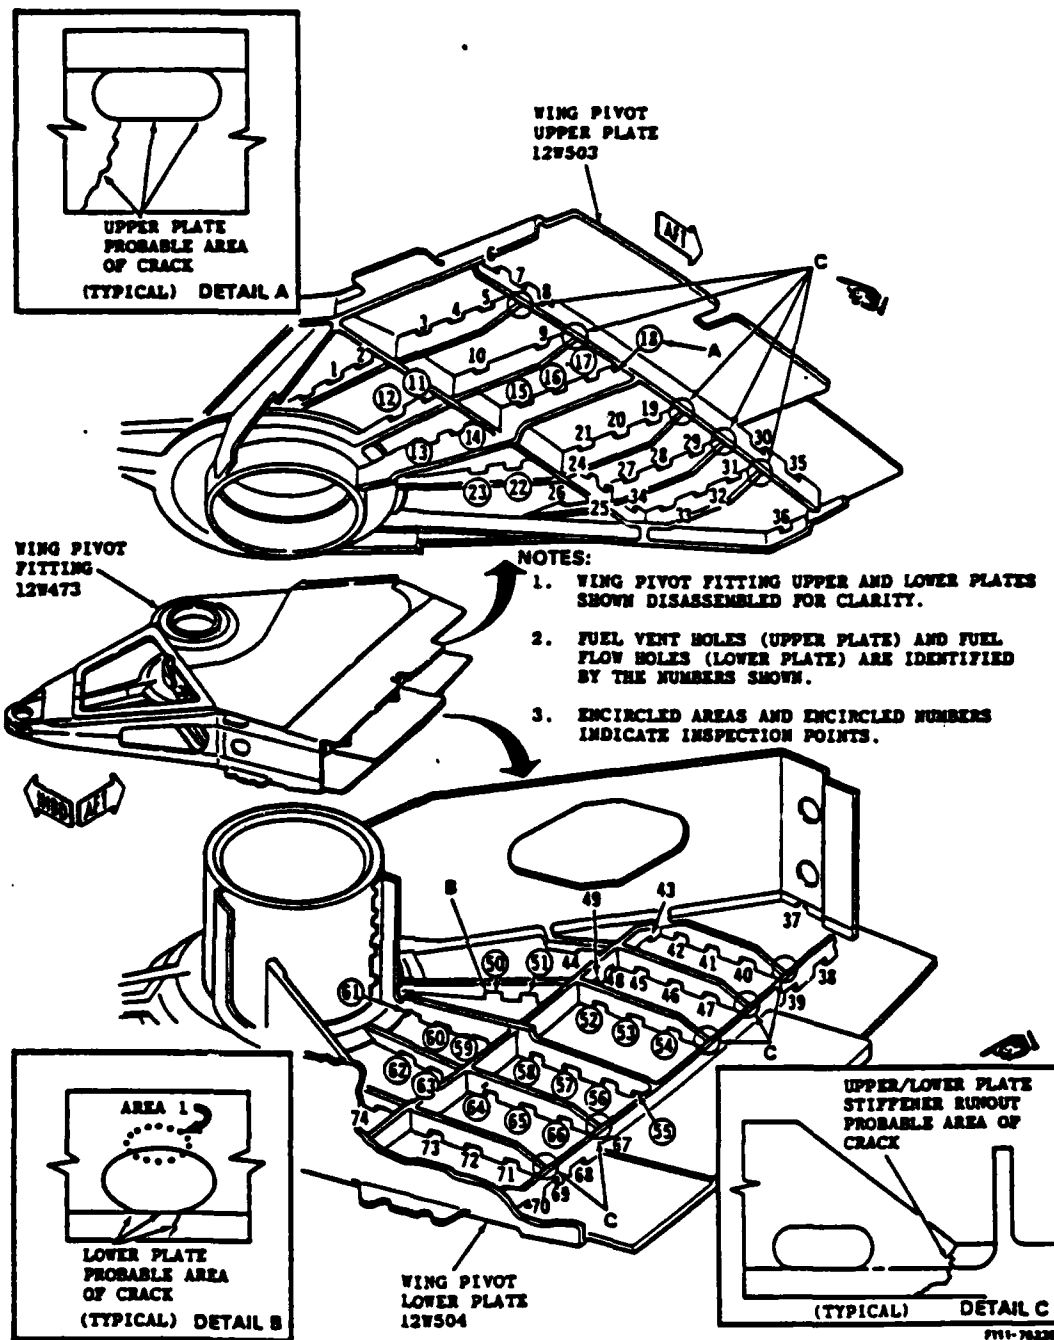
Fig. 1. Wing Pivot Fitting - Fuel Flow/Vent Holes and Stiffener Runouts
